**FUNDAMENTAL MECHANISMS OF
TENSILE FRACTURE IN ALUMINUM SHEET
UNIDIRECTIONALLY REINFORCED
WITH BORON FILAMENT**

*by Harvey W. Herring
Langley Research Center
Hampton, Va. 23365*

1. Report No. NASA TR R-383		2. Government Accession No.		3. Recipient's Catalog No.	
4. Title and Subtitle FUNDAMENTAL MECHANISMS OF TENSILE FRACTURE IN ALUMINUM SHEET UNIDIRECTIONALLY REINFORCED WITH BORON FILAMENT				5. Report Date April 1972

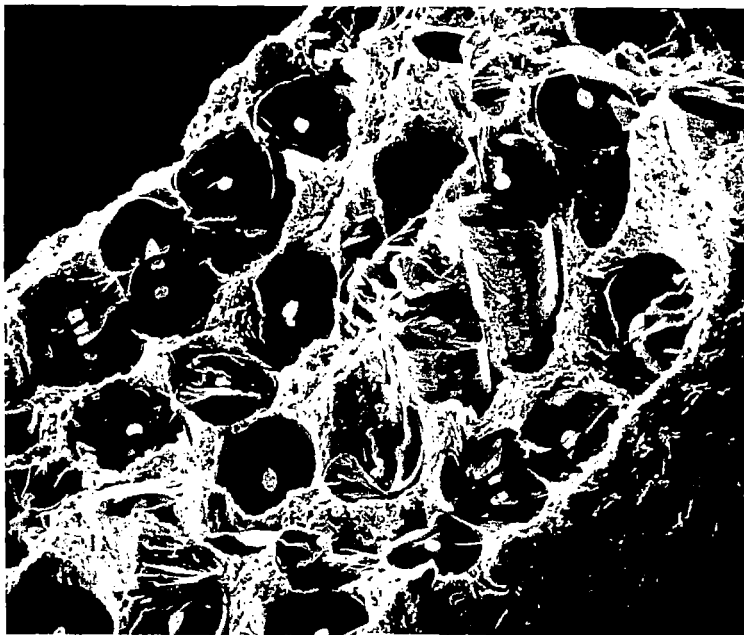
L-72-181

Figure 37.- Leftmost transition region between transverse noncumulative and cumulative fracture in fracture surface of figure 36.

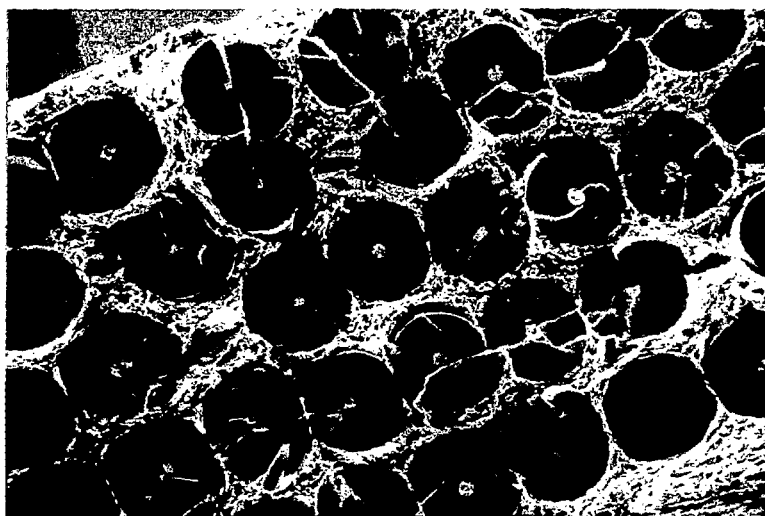
L-72-182

Figure 38.- Second transverse region from left
edge of fracture surface of figure 36.

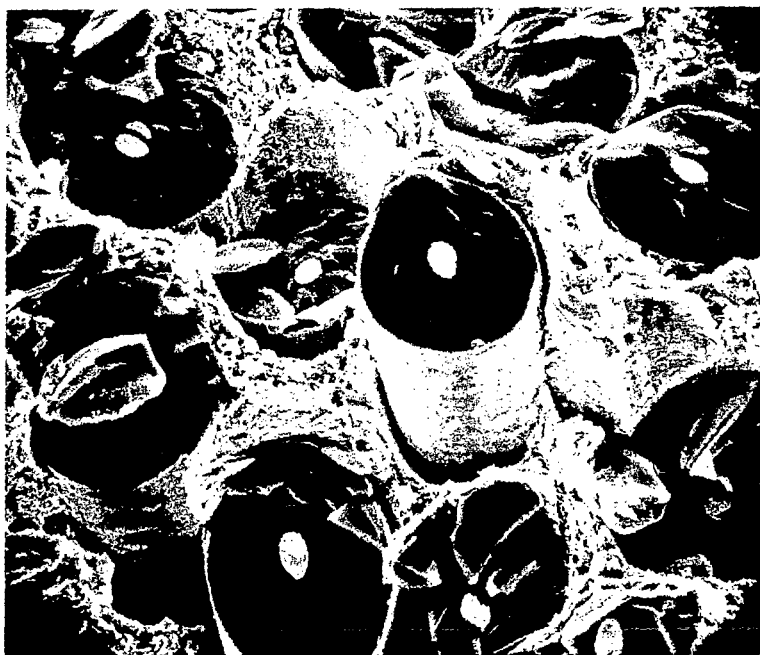
L-72-183

Figure 39.- Left-hand boundary of second transverse
region of figure 36.

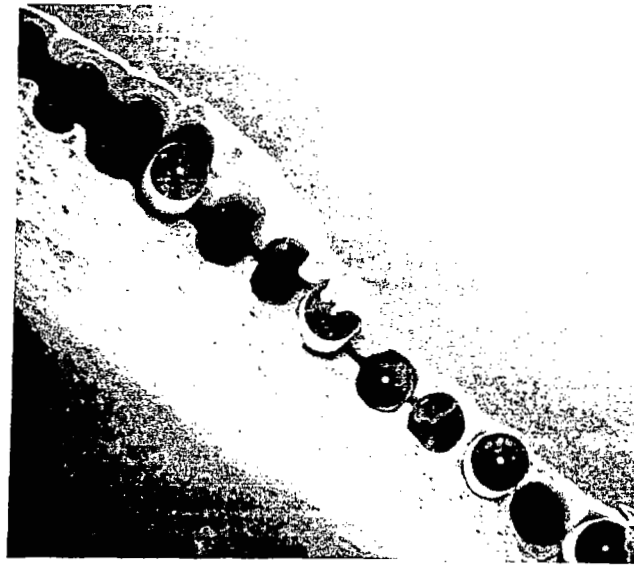
L-72-186

Figure 42.- Delamination in extremely weakly bonded region of commercially fabricated monolayer composite. Filament diameter, 0.14 mm (0.0056 in.).

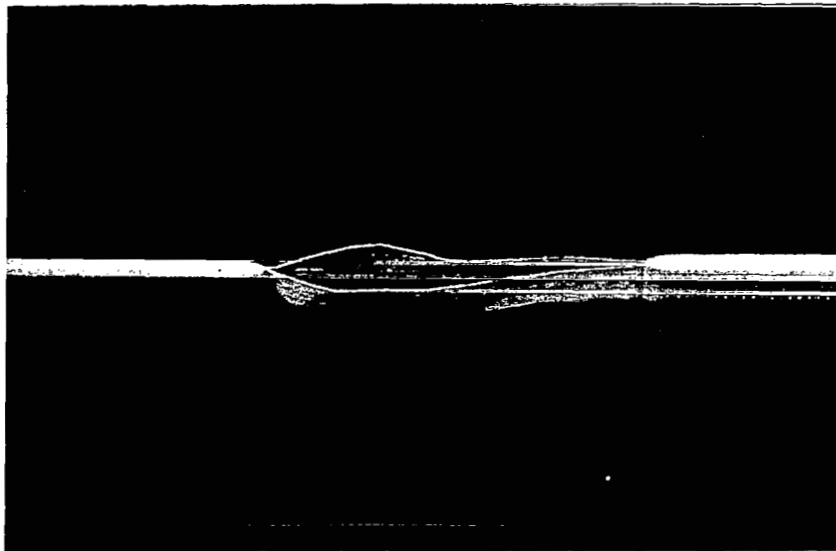
L-72-187

Figure 43.- Gross delamination of extremely weakly bonded specimen of commercially fabricated monolayer composite. Filament diameter, 0.14 mm (0.0056 in.).

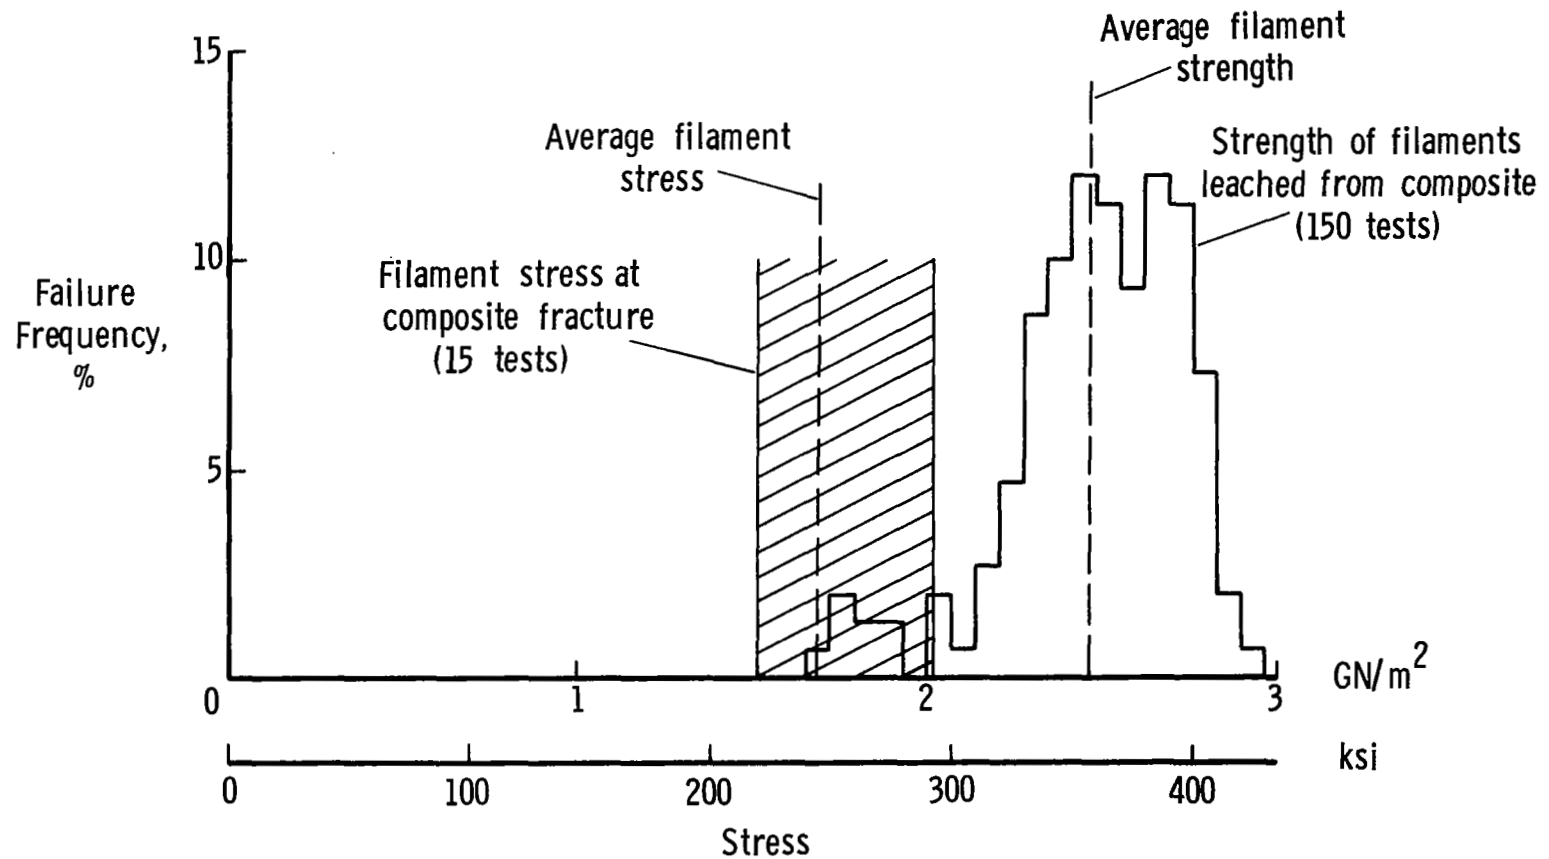
Figure 44.- Average filament stress at composite fracture and filament strength in composite for monolayer sheet containing 0.14-mm-diameter (0.0056-in.) boron filaments. Consolidated under pressure of 69 MN/m² (10 ksi) at 866 K (1100° F).

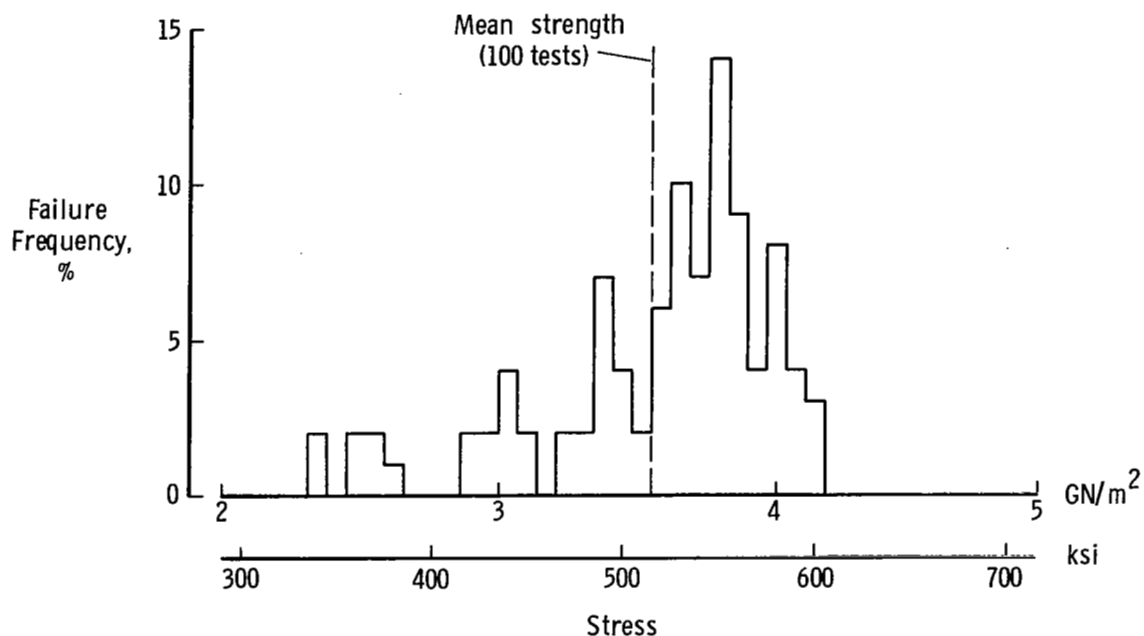
Figure 45.- Failure-frequency histogram for virgin 0.14-mm-diameter (0.0056-in.) boron filament.

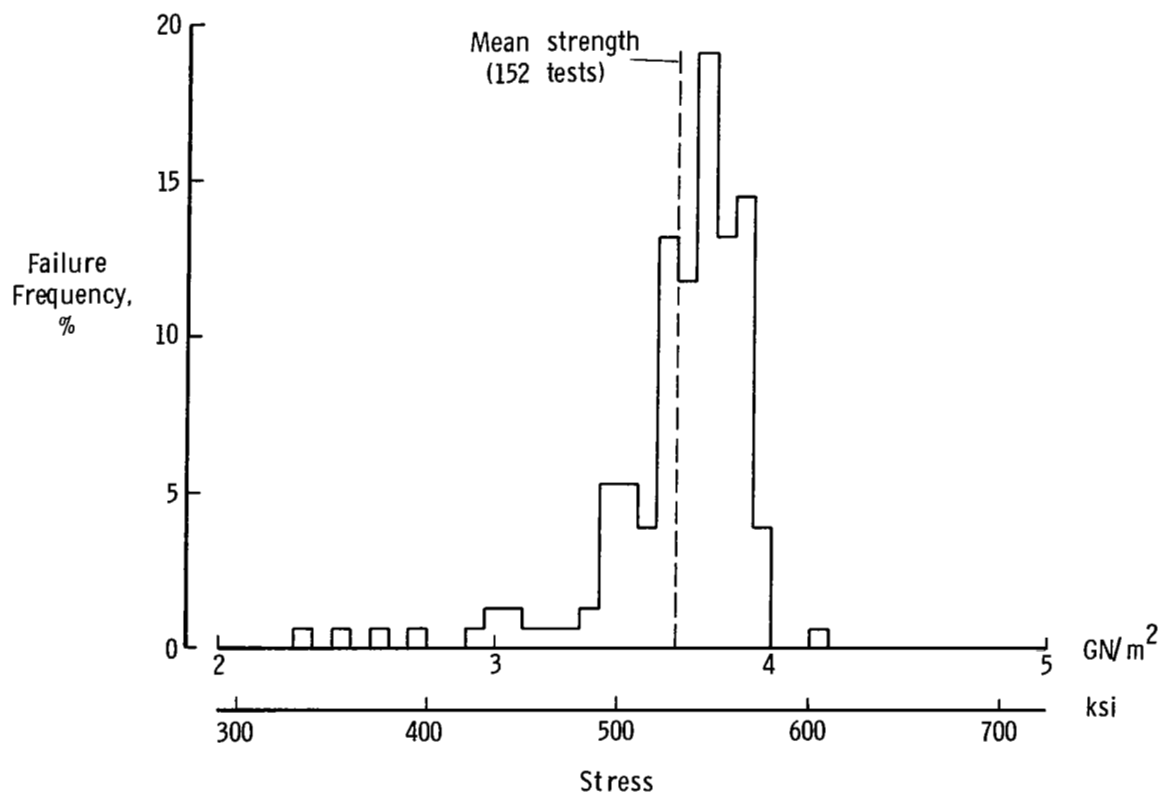
Figure 46.- Failure-frequency histogram for virgin 0.099-mm-diameter (0.0039-in.) boron filament.

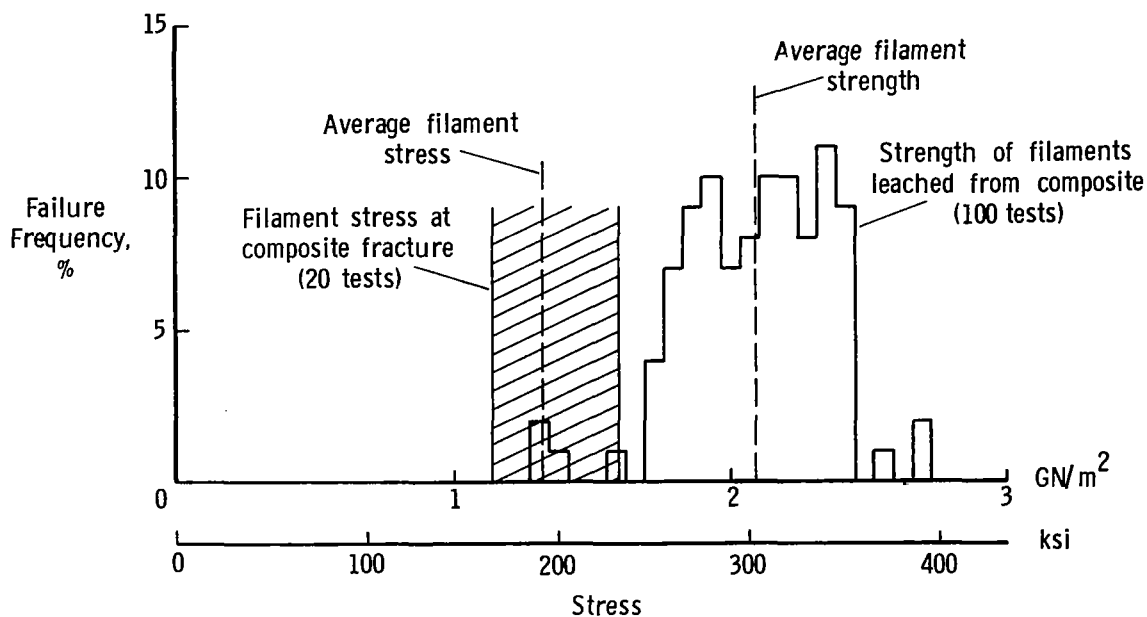
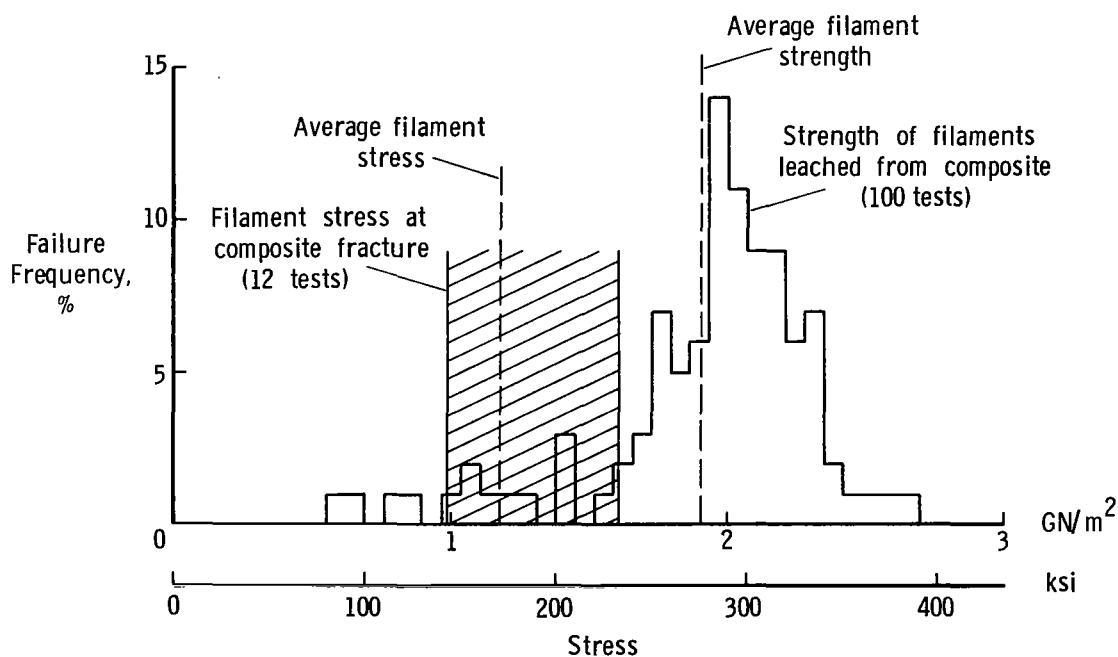
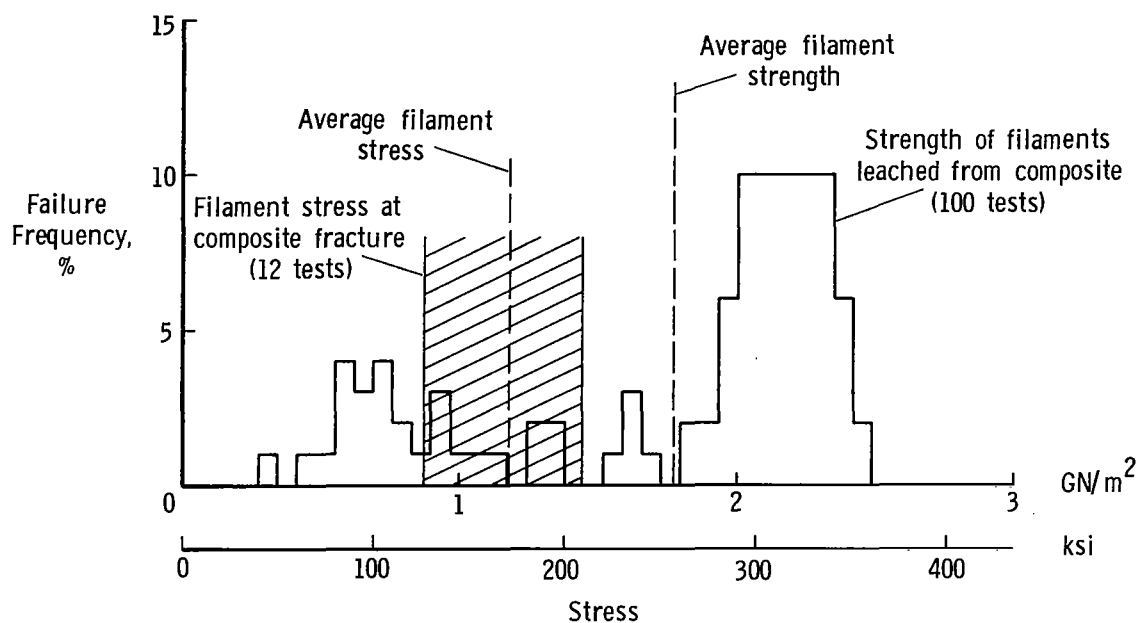
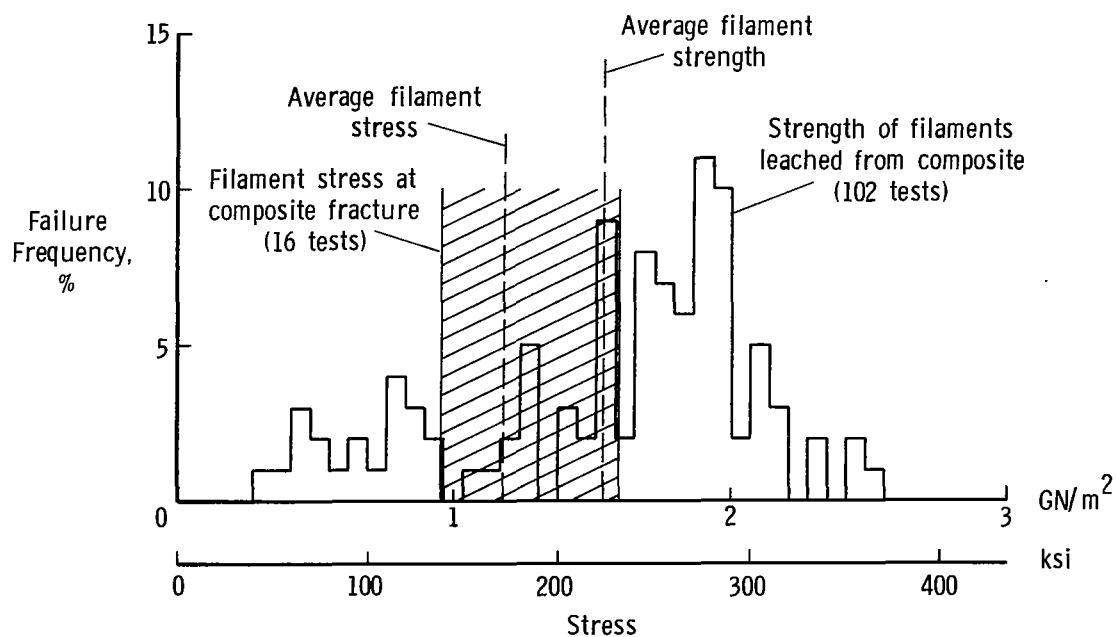
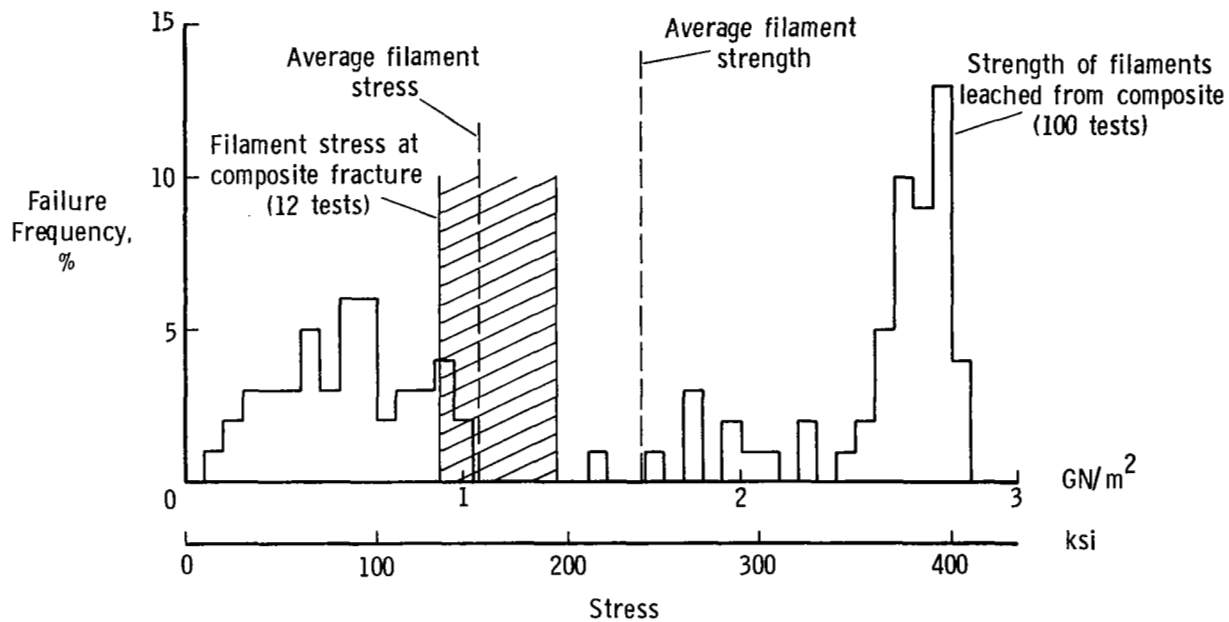
(a) Consolidated under pressure of 69 MN/m² (10 ksi) at 866 K (1100° F).

(b) Consolidated under pressure of 76 MN/m² (11 ksi) at 866 K (1100° F).

Figure 47.- Average filament stress at composite fracture and filament strength in composite for bilayer sheet containing 0.099-mm-diameter (0.0039-in.) boron filaments.

(c) Consolidated under pressure of 83 MN/m² (12 ksi) at 866 K (1100° F).

(d) Consolidated under pressure of 90 MN/m² (13 ksi) at 866 K (1100° F).

(e) Consolidated under pressure of 103 MN/m^2 (15 ksi) at 866 K (1100° F).

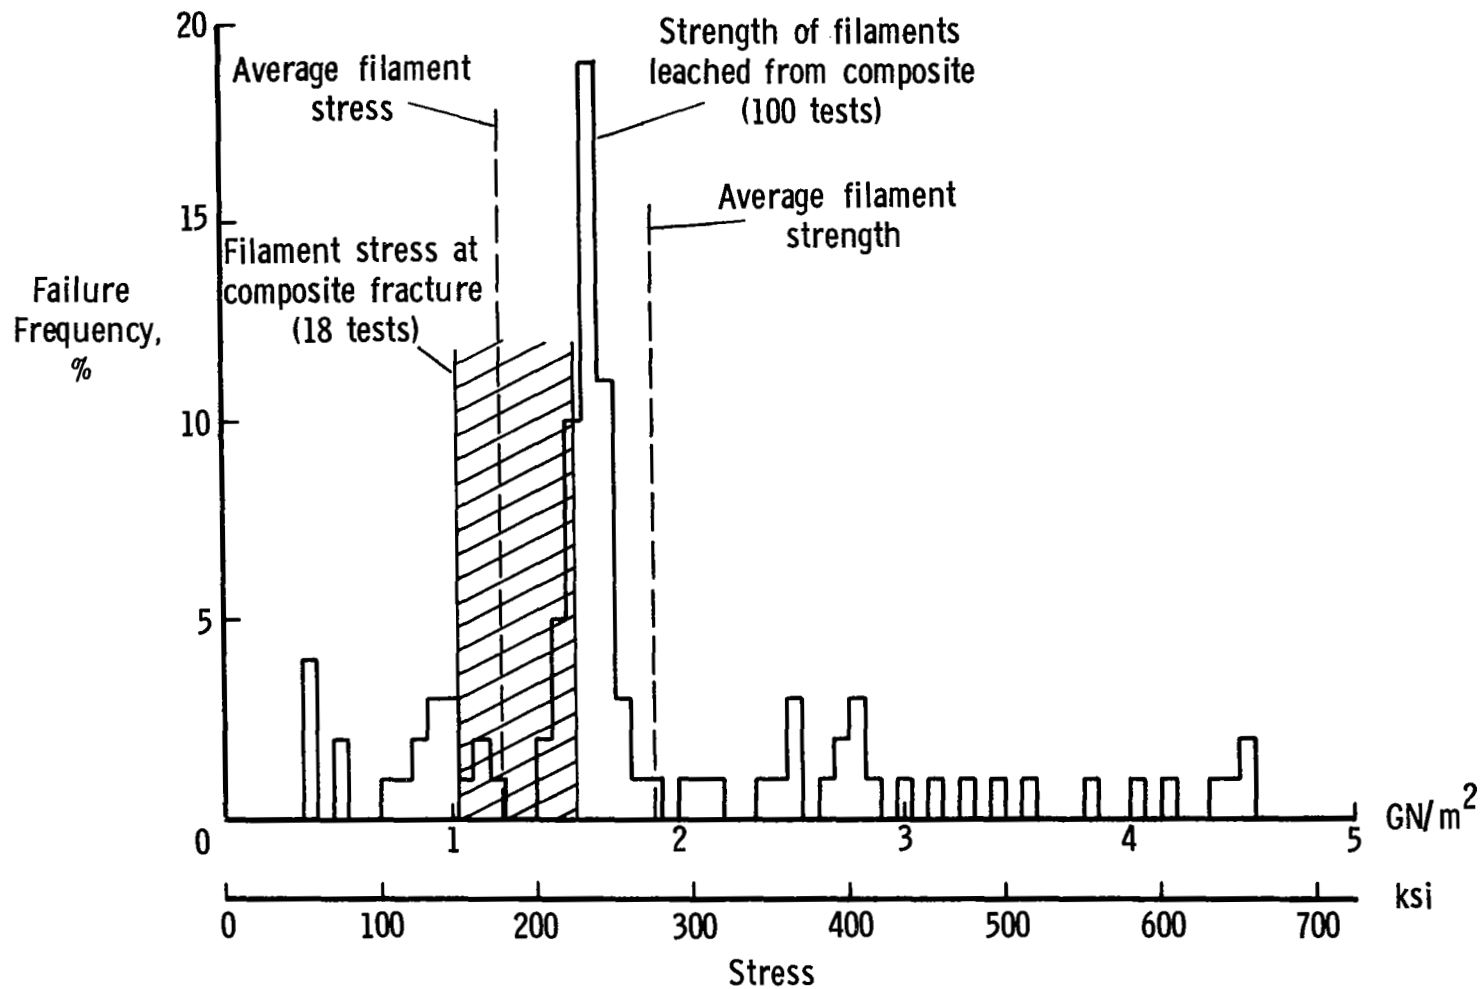
Figure 48.- Average filament stress at composite fracture and filament strength in composite for bilayer sheet containing 0.089-mm-diameter (0.0035-in.) boron filaments. Consolidated under pressure of 62 MN/m² (9 ksi) at 783 K (950° F).

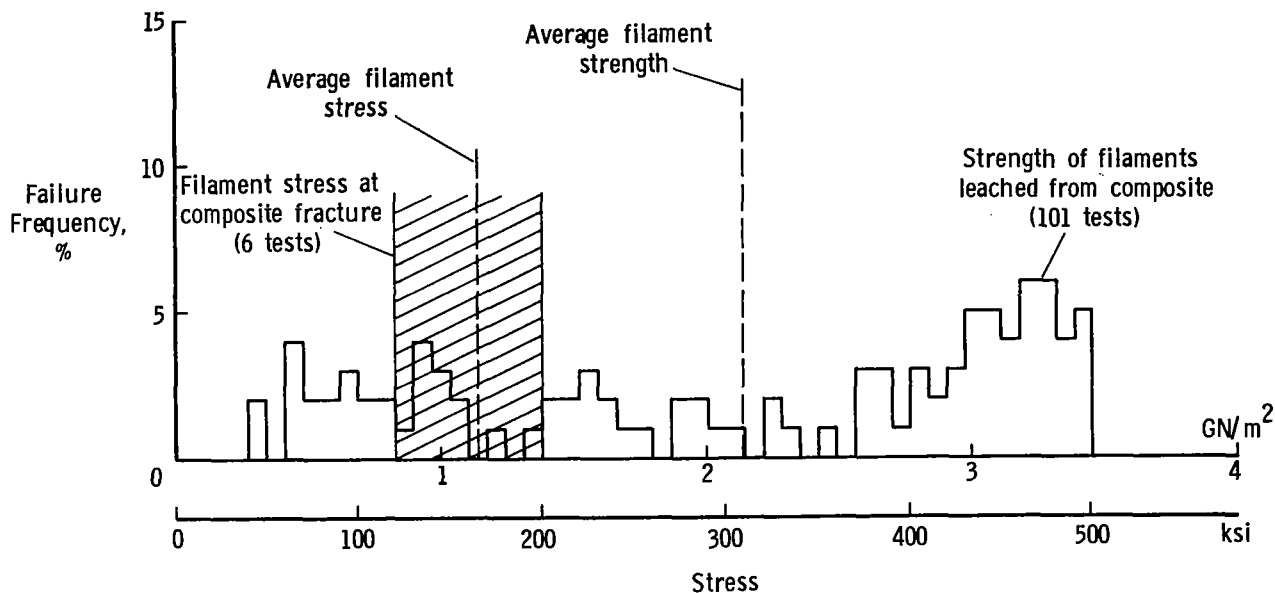
Figure 49.- Average filament stress at composite fracture and filament strength in composite for commercially fabricated five-layer sheet containing 0.10-mm-diameter (0.0041-in.) silicon-carbide-coated boron filaments.

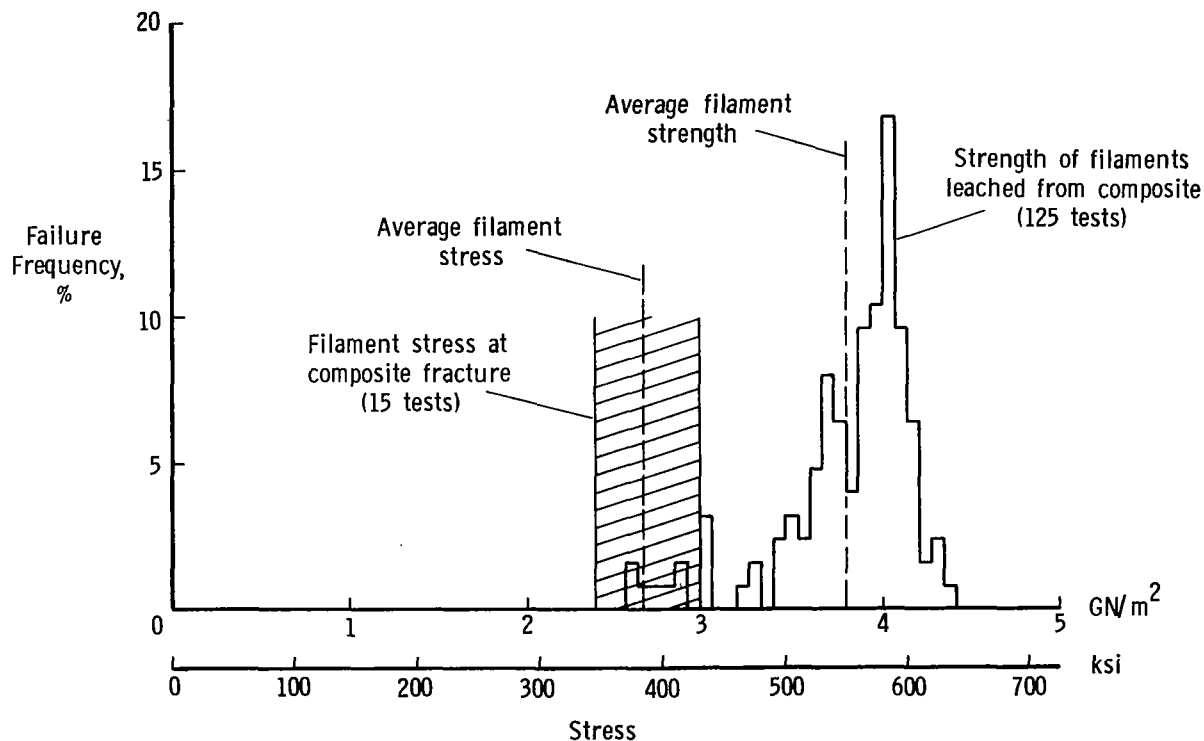
Figure 50.- Average filament stress at composite fracture and filament strength in composite for commercially fabricated monolayer sheet containing 0.14-mm-diameter (0.0056-in.) boron filaments.

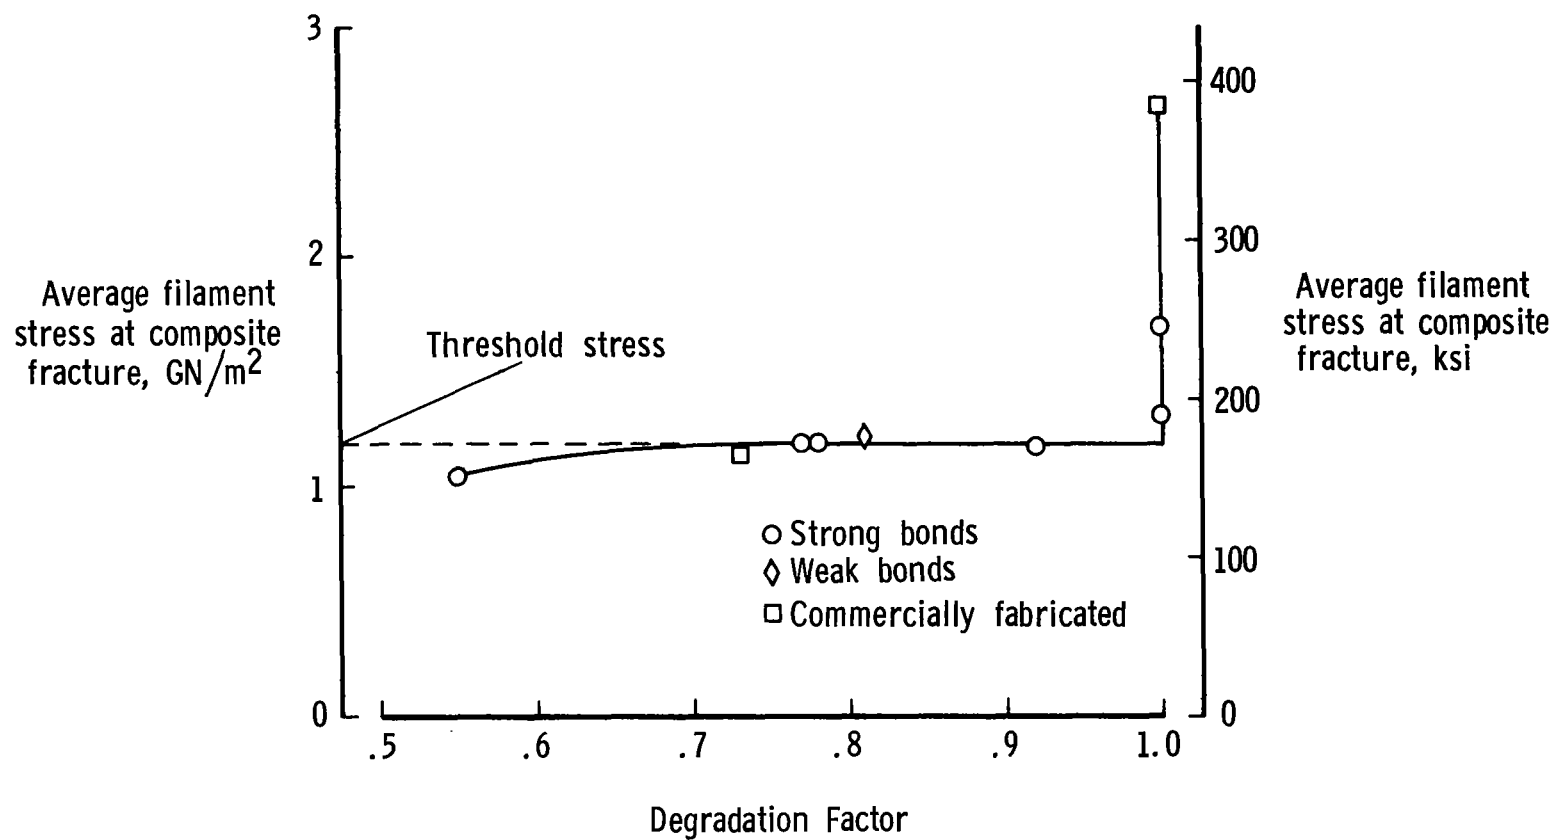
Figure 51.- Threshold stress for initiation and sustenance of noncumulative filament-break propagation in unidirectional B-Al composite sheet.

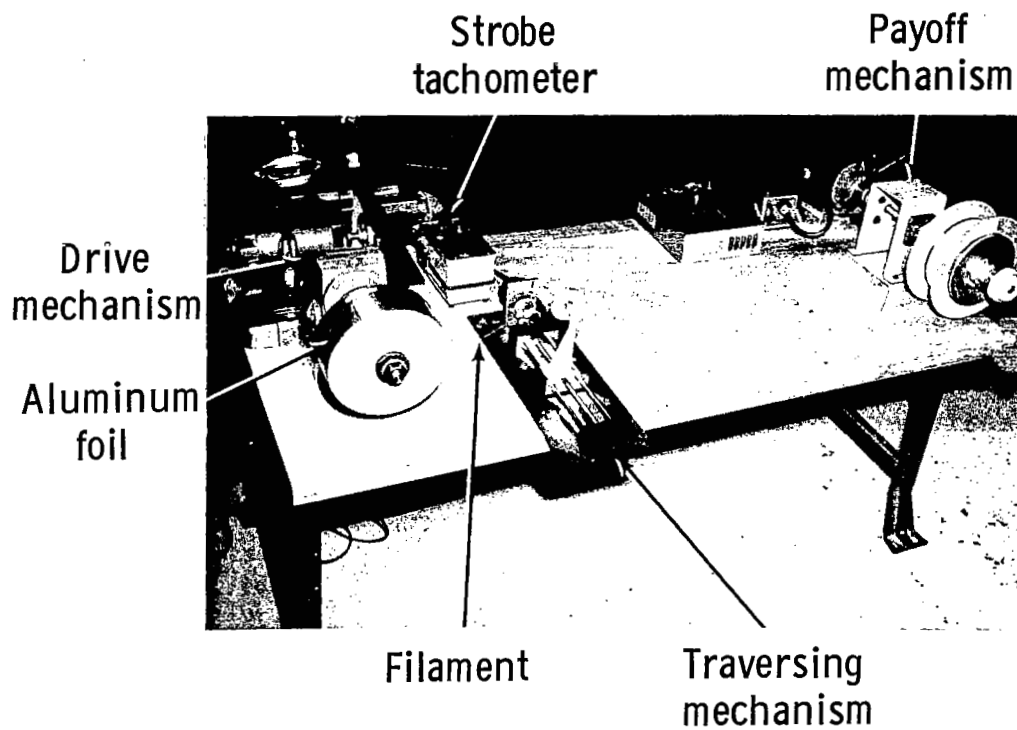
L-72-190

Figure 54.- Filament-winding apparatus used in fabrication
of B-Al composite sheet.
